# IMPORTANT SAFETY NOTICE

## ZIPP® 88 aluminum front hub

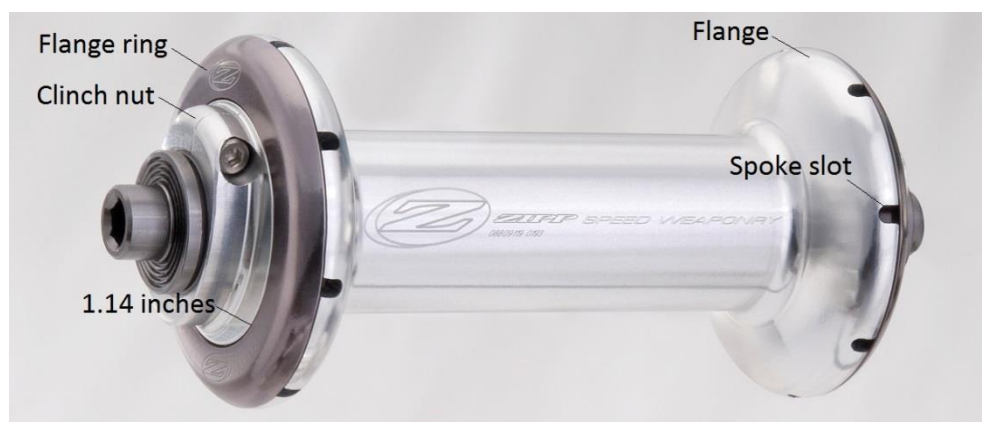
SRAM, LLC has determined that the hub flange and flange ring on the certain ZIPP 88 aluminum front hubs can fail, posing a crash risk and injury hazard. The affected ZIPP 88 hub model is readily identifiable by the design of the external flange ring which is pictured above.

Consumers with bicycle wheels equipped with potentially affected ZIPP 88 front hubs should stop riding immediately and return their wheel to SRAM or their local bicycle dealer for verification and to obtain a free replacement product.
